ON-SITE AIR BAG INVESTIGATION

CASE NO. - 96-16
FLEET - PRIVATE VEHICLE
LOCATION -
ACCIDENT DATE -

TRC/IU CASE NO. 96-16

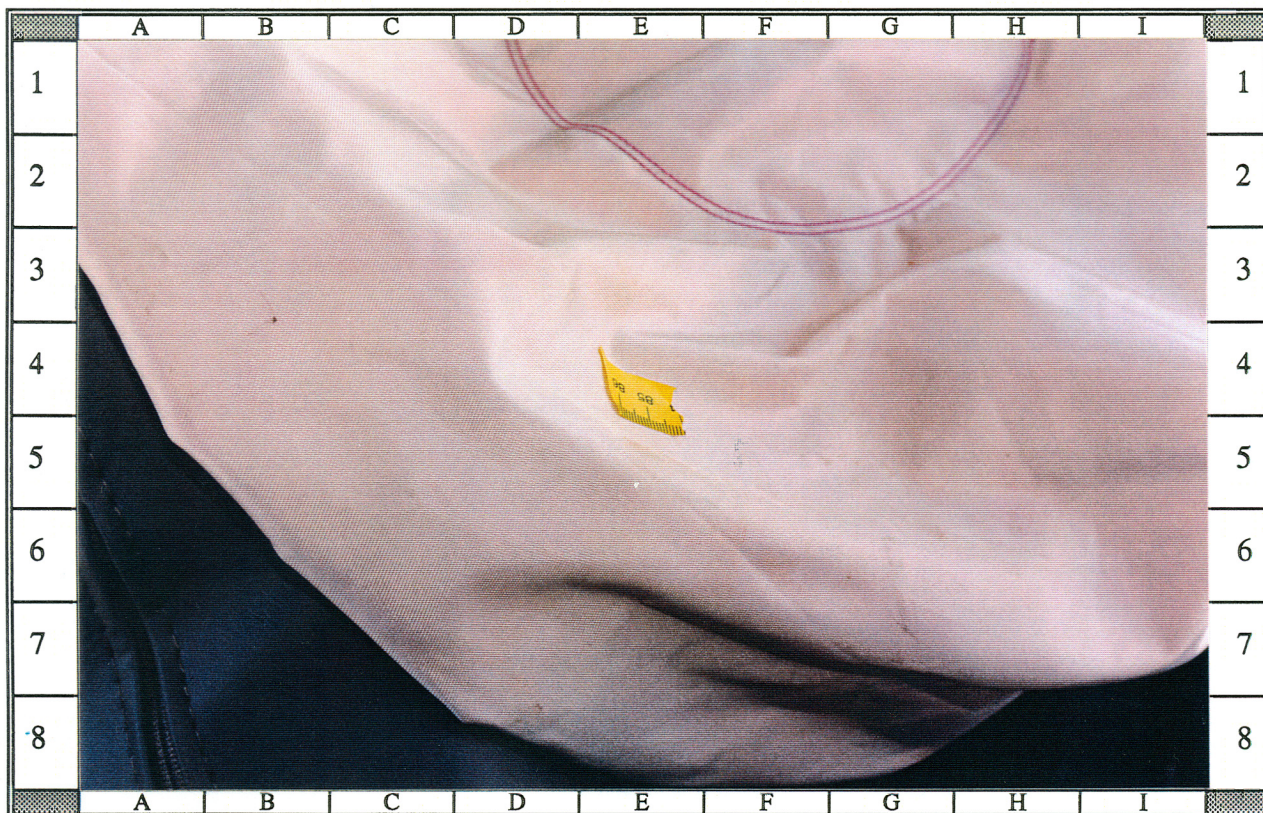
57: Close-up of Case Vehicle's deployed driver air bag showing a possible occupant contact point (i.e., unknown substance) in lower center of air bag

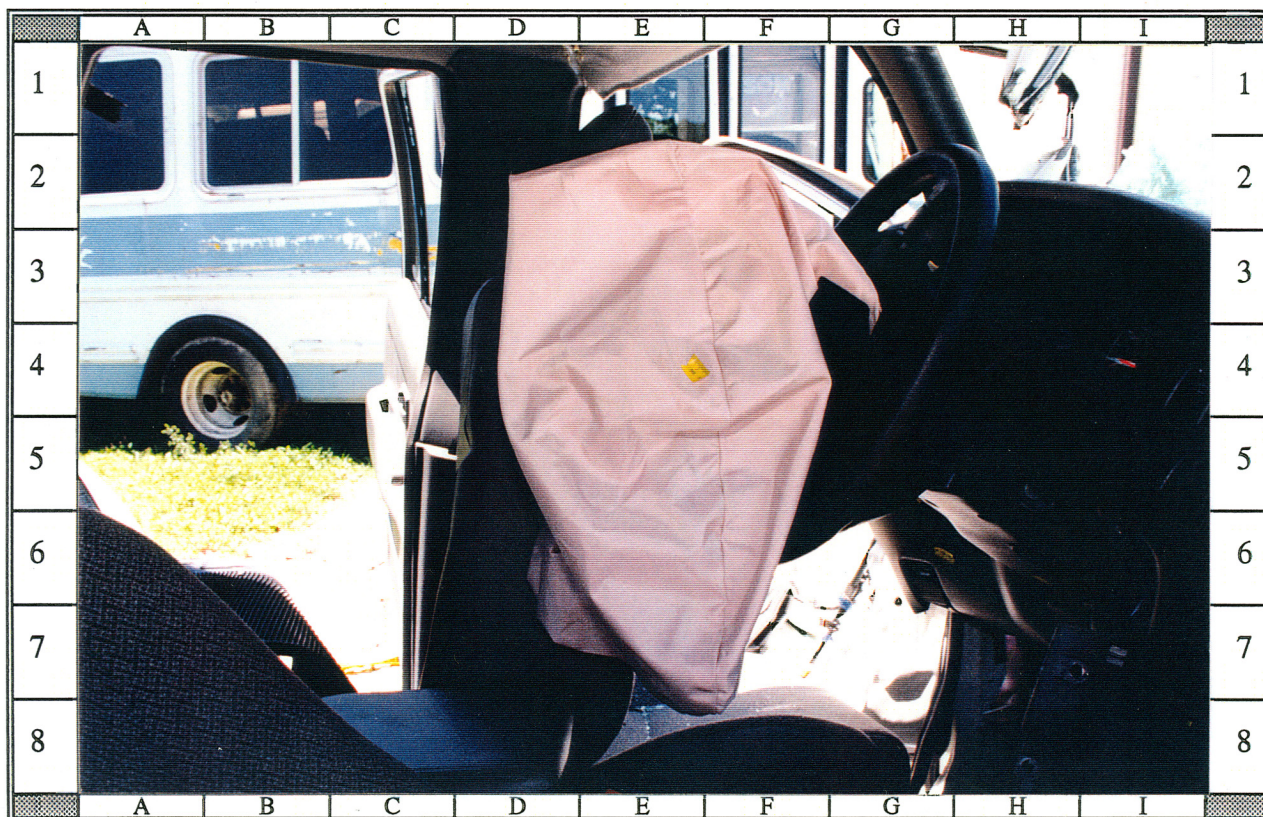
58: Case Vehicle's driver seating area viewed from right showing deployed driver side air bag; NOTE: unknown substance on air bag near right seam

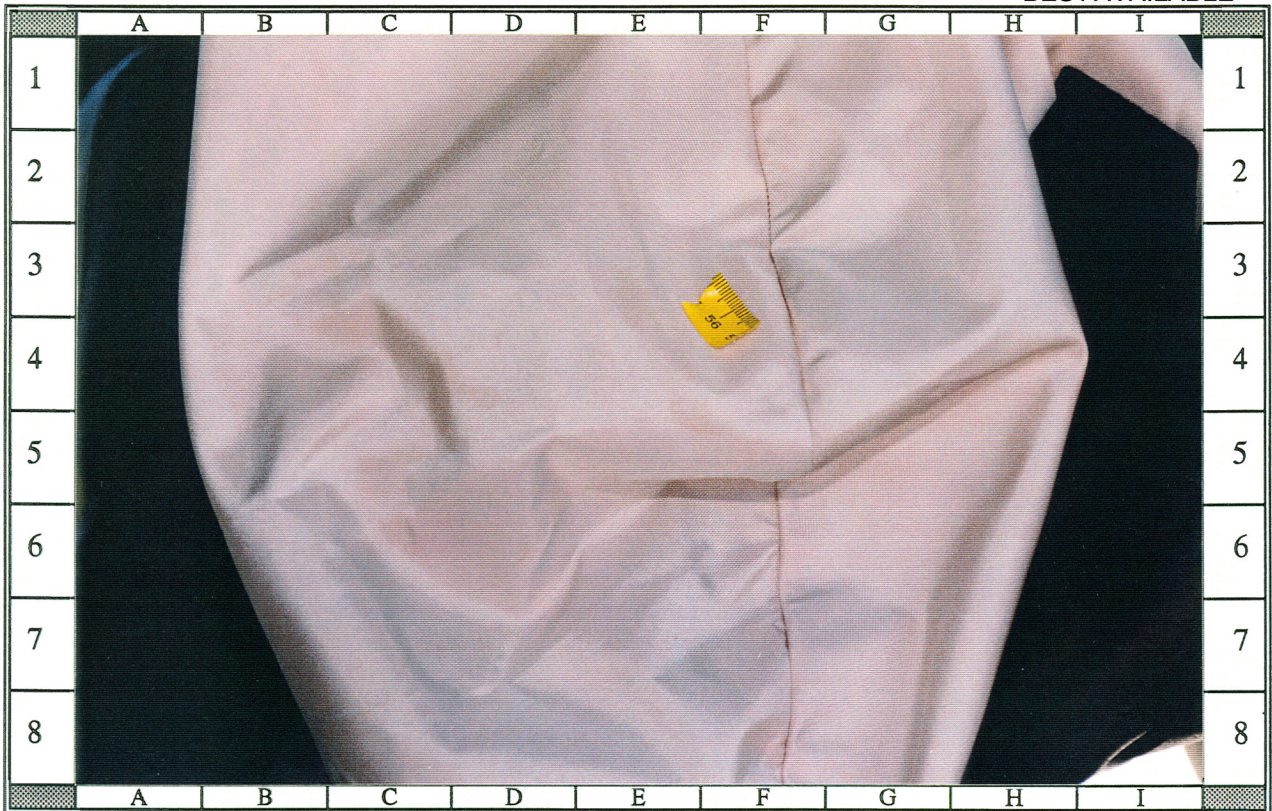
59: Close-up of Case Vehicle's deployed driver side air bag showing unknown substance near right seam

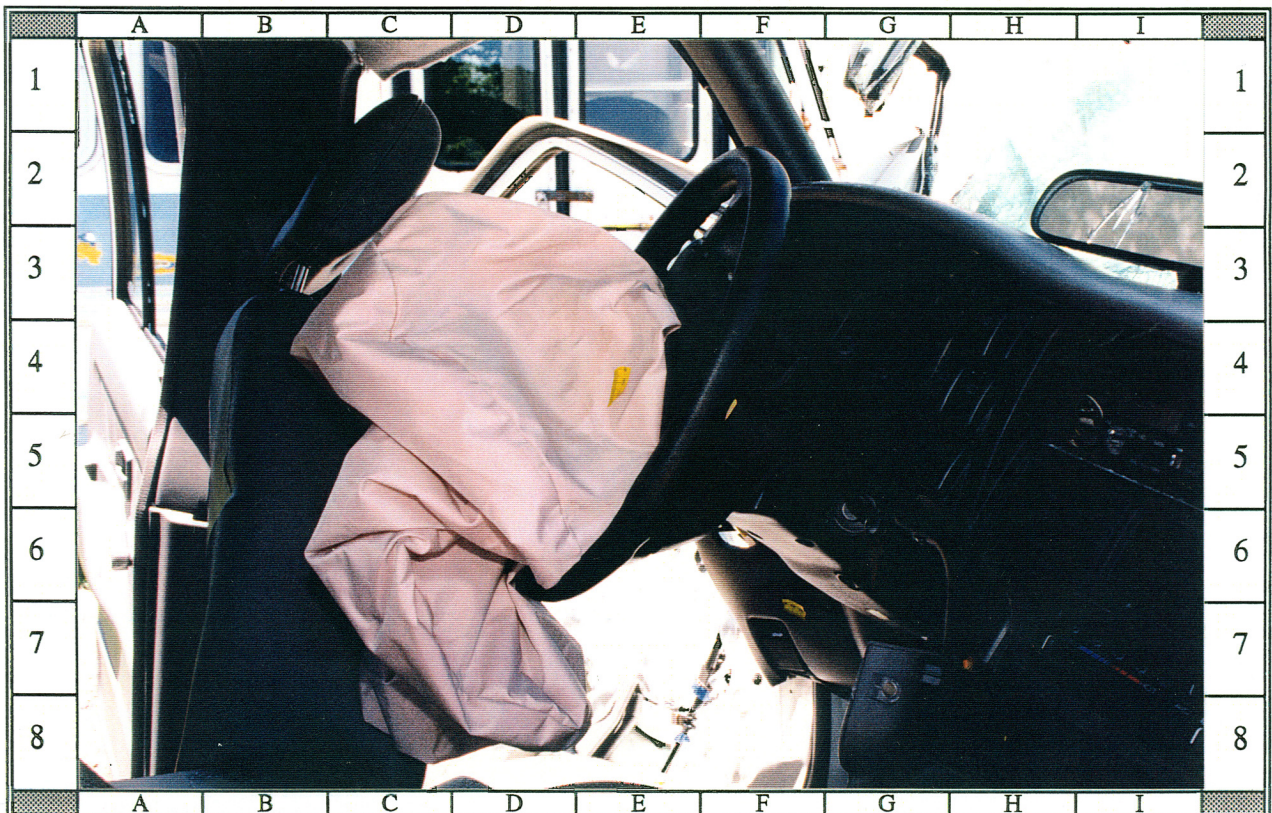
60: Case Vehicle's driver seating area viewed from right showing deployed driver side air bag; NOTE: unknown substance on right backside of air bag

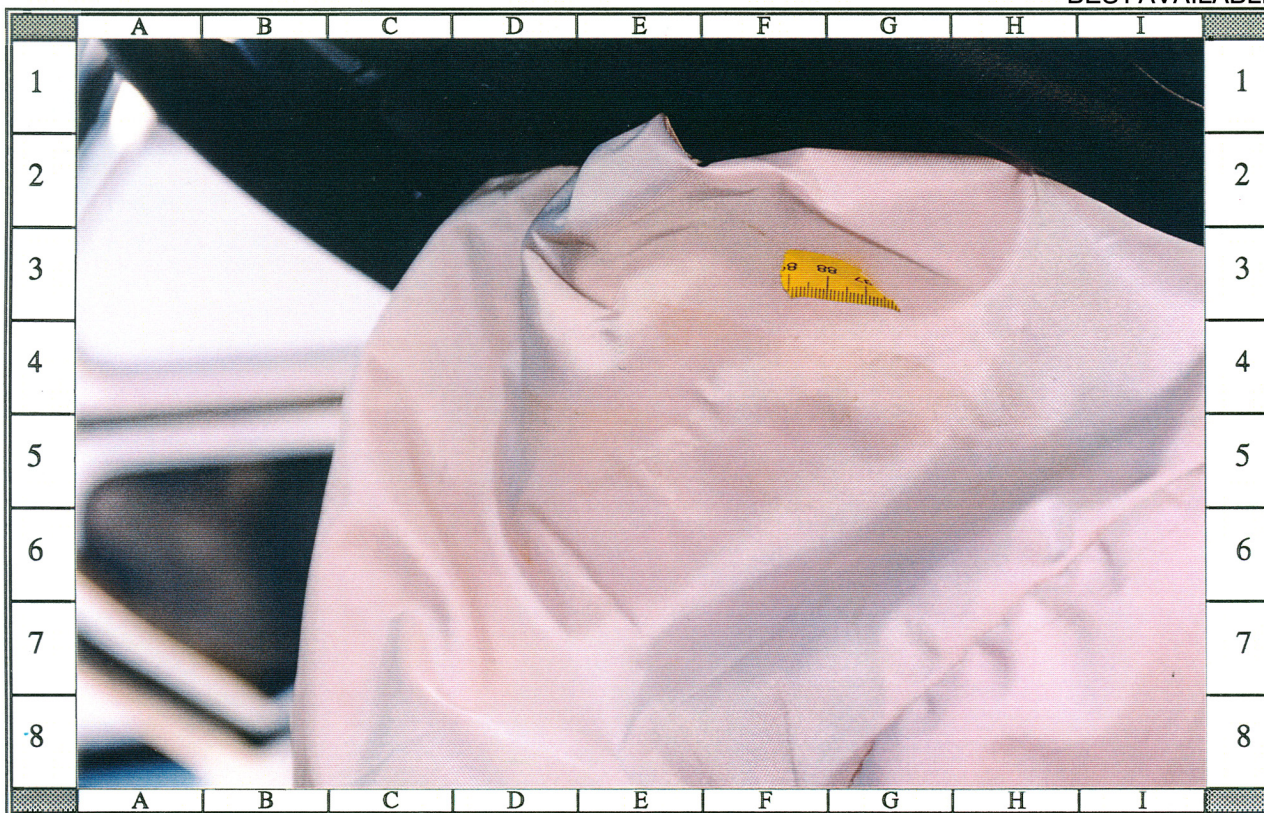
61: Close-up of Case Vehicle's deployed driver air bag showing an unknown substance on lower right backside of deployed air bag

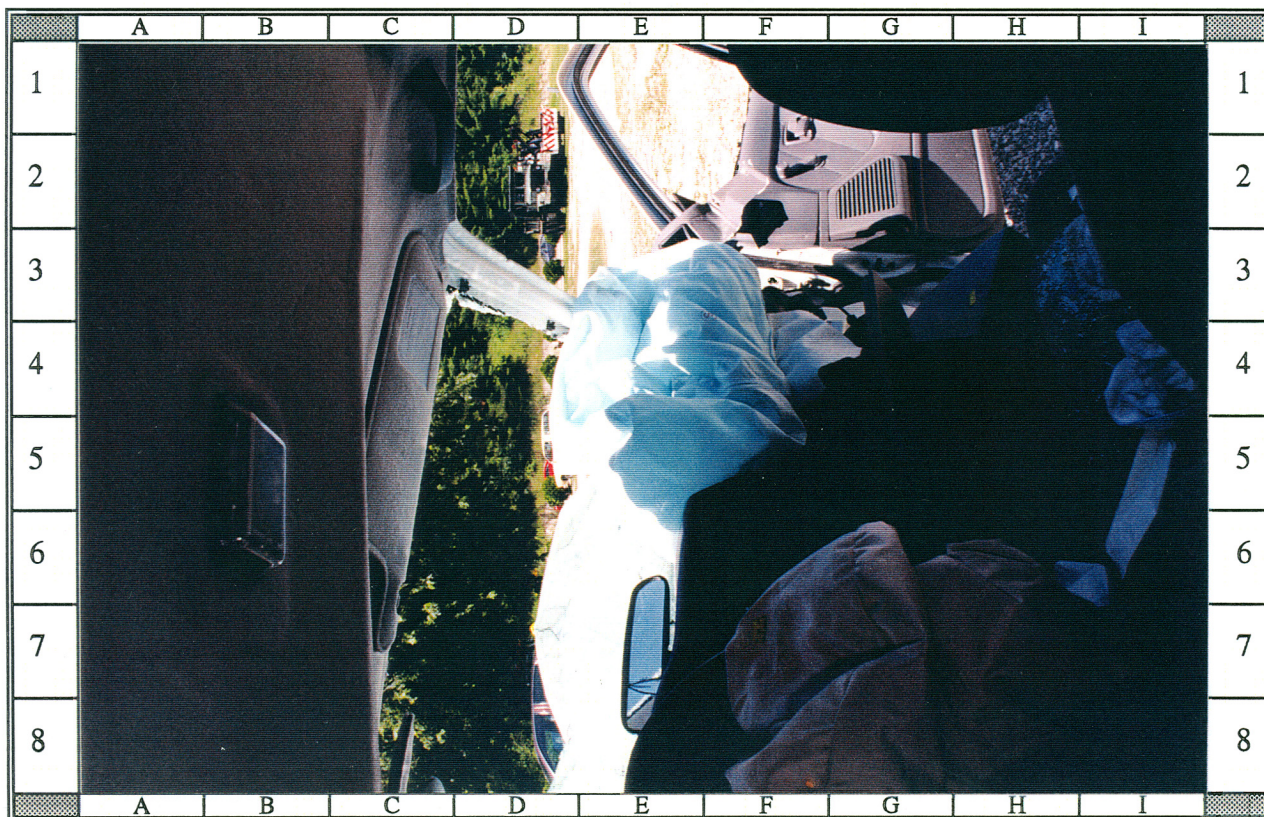
62: Case Vehicle's right front seating area viewed from left rear showing deployed air bags; NOTE: no contact evidence to right header, sunvisor, or side rail areas

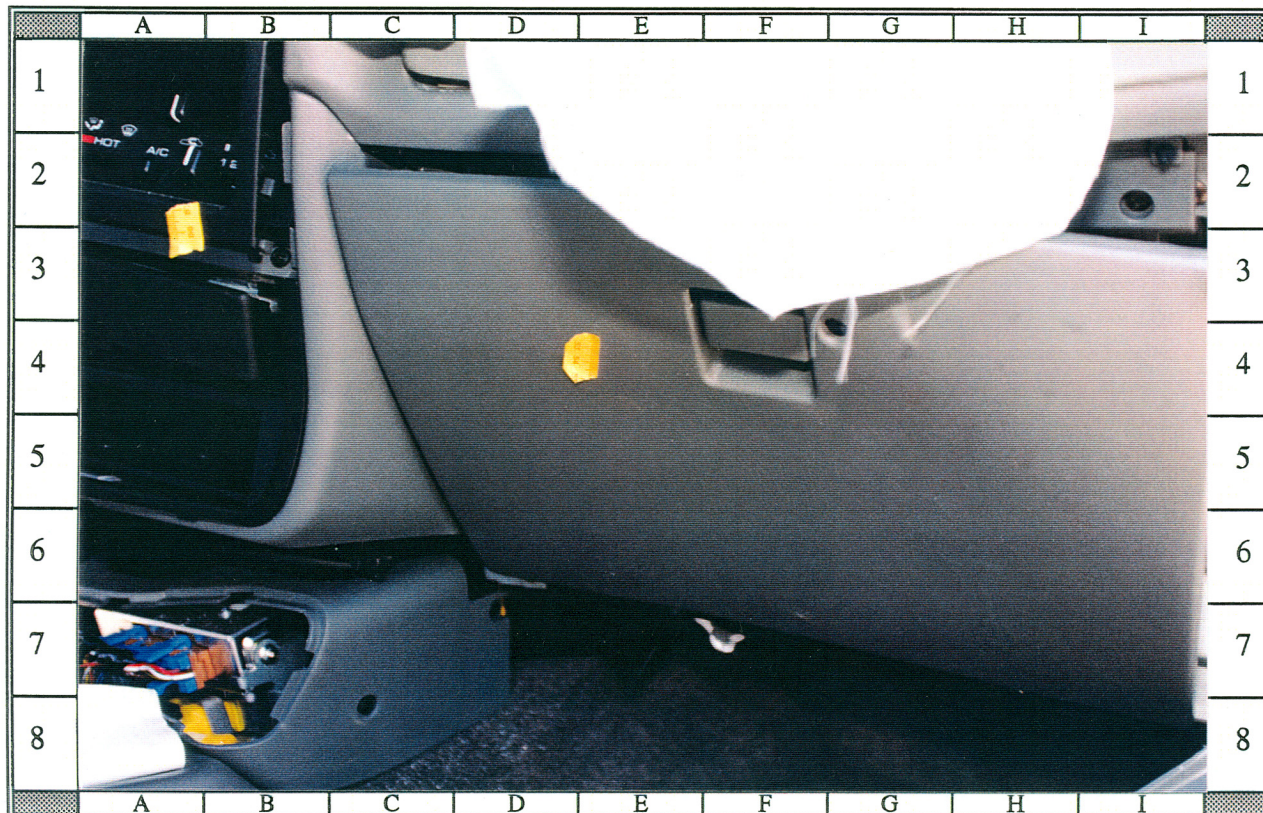
63: Close-up of Case Vehicle's center dash area showing displaced plastic covering, broken radio face, possible center contact, and deployed right front air bag

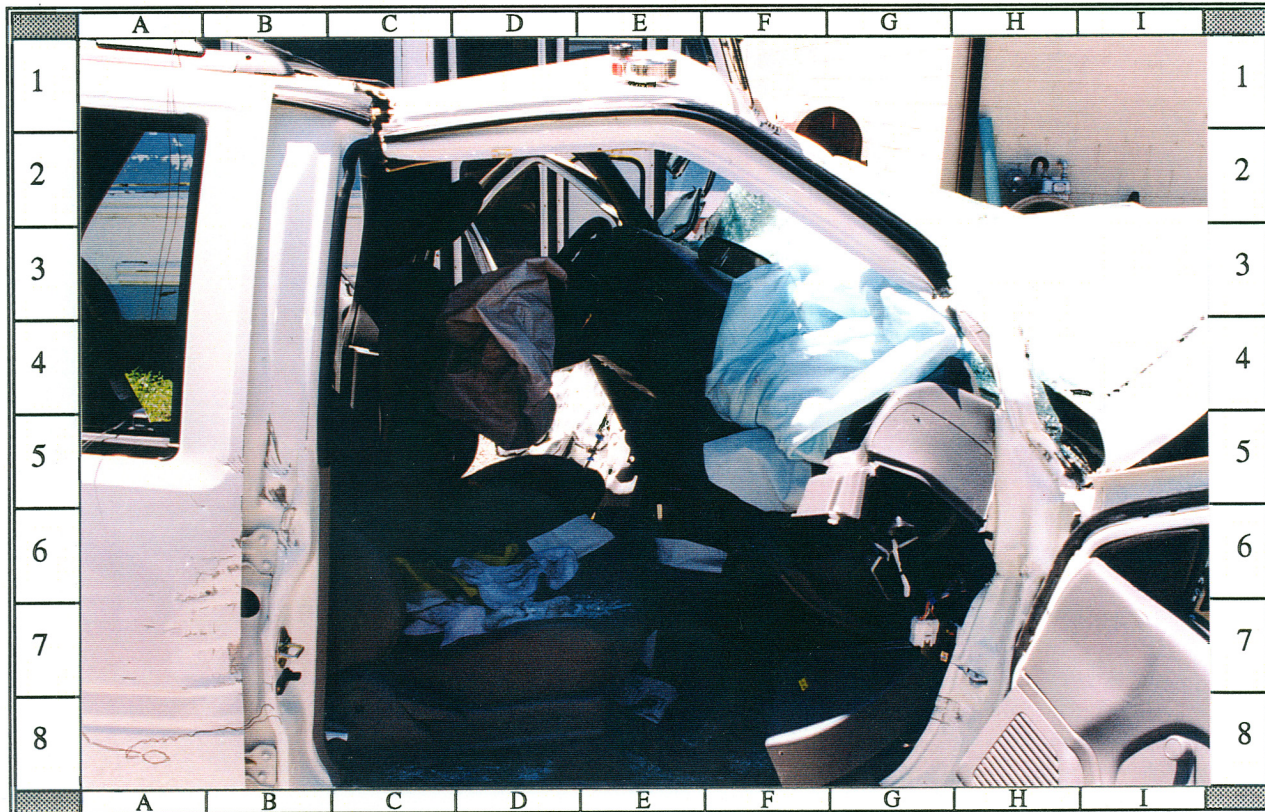
65: Case Vehicle's front seating area viewed through disintegrated right front glazing;
NOTE: windshield collapsed over passenger's air bag after extrication

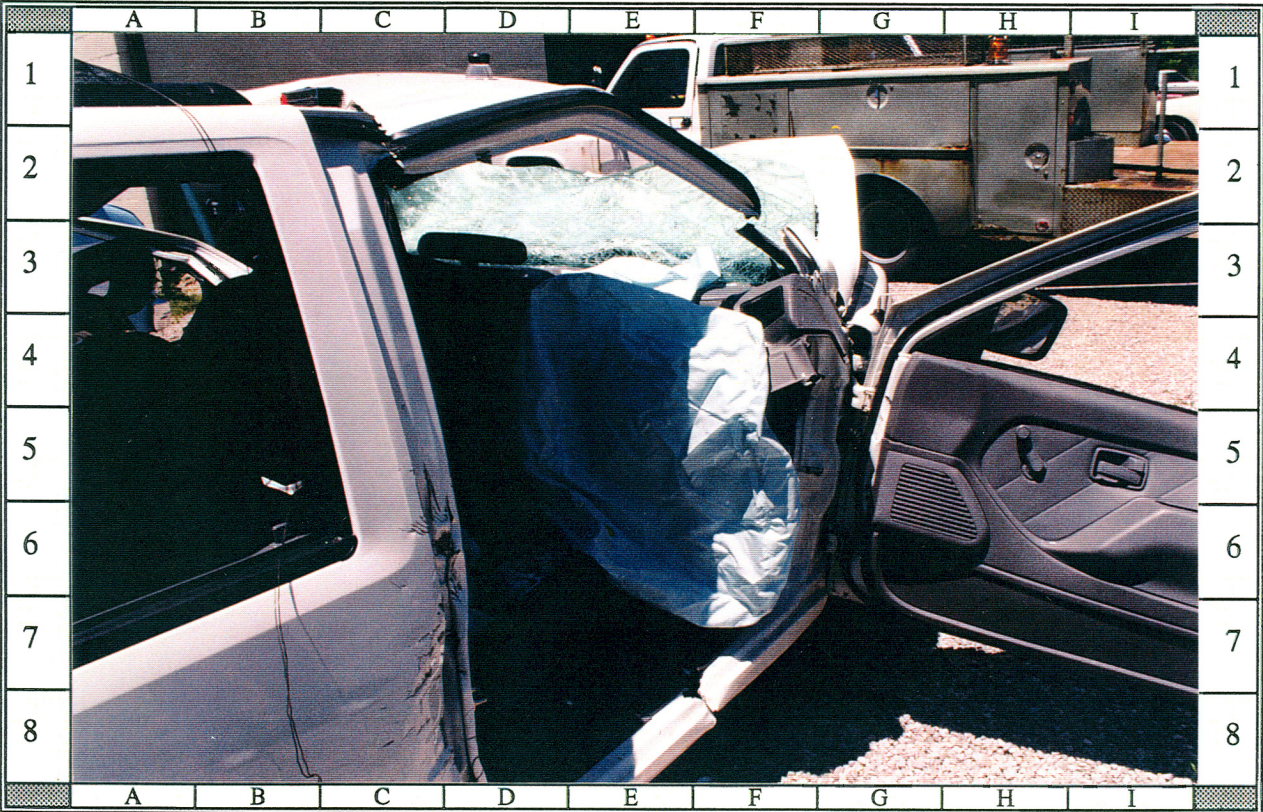
68: Interior surface of Case Vehicle’s right front door showing no contacts; NOTE: deployed passenger air bag, cut "A"-pillar, and windshield folded onto hood

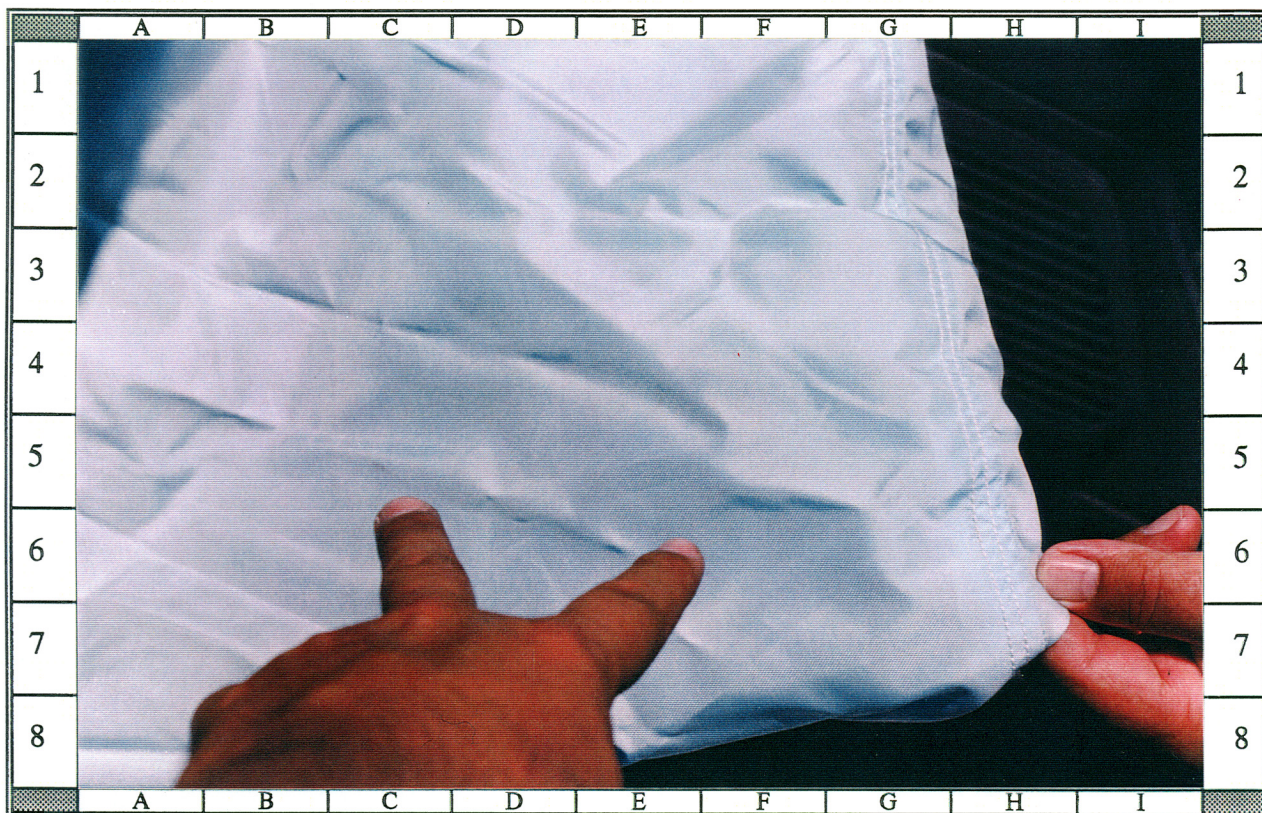
71: Close-up of Case Vehicle's deployed right front passenger air bag showing possible occupant contact (i.e., between fingers) on air bag's lower right quadrant

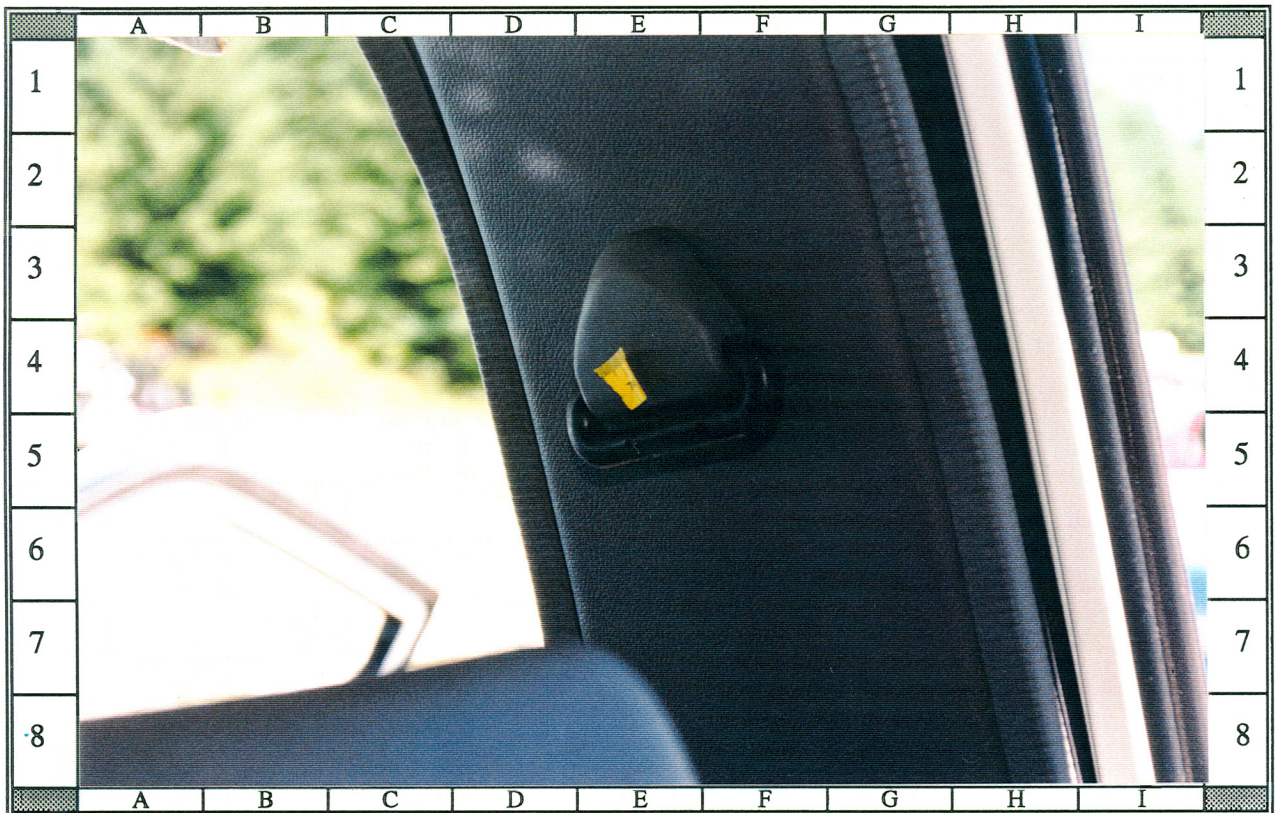
73: Close-up of Case Vehicle's right front "D"-ring on right "B"-pillar; NOTE: "D"-ring shows evidence of loading from right front passenger's safety belt

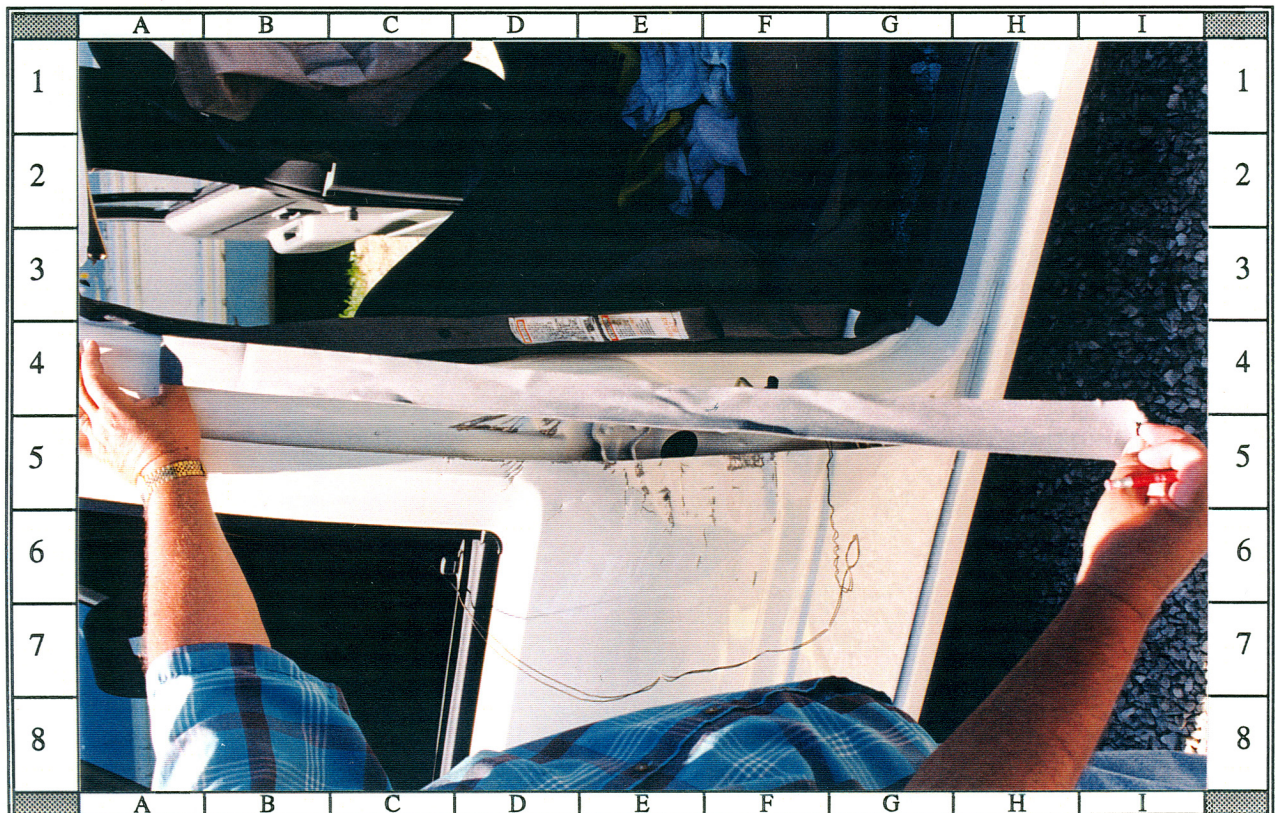
74: Underneath side of Case Vehicle's right front safety belt showing occupant load-stretch marks; NOTE: belt cut (cells I4--I5) by EMTs to enable extrication

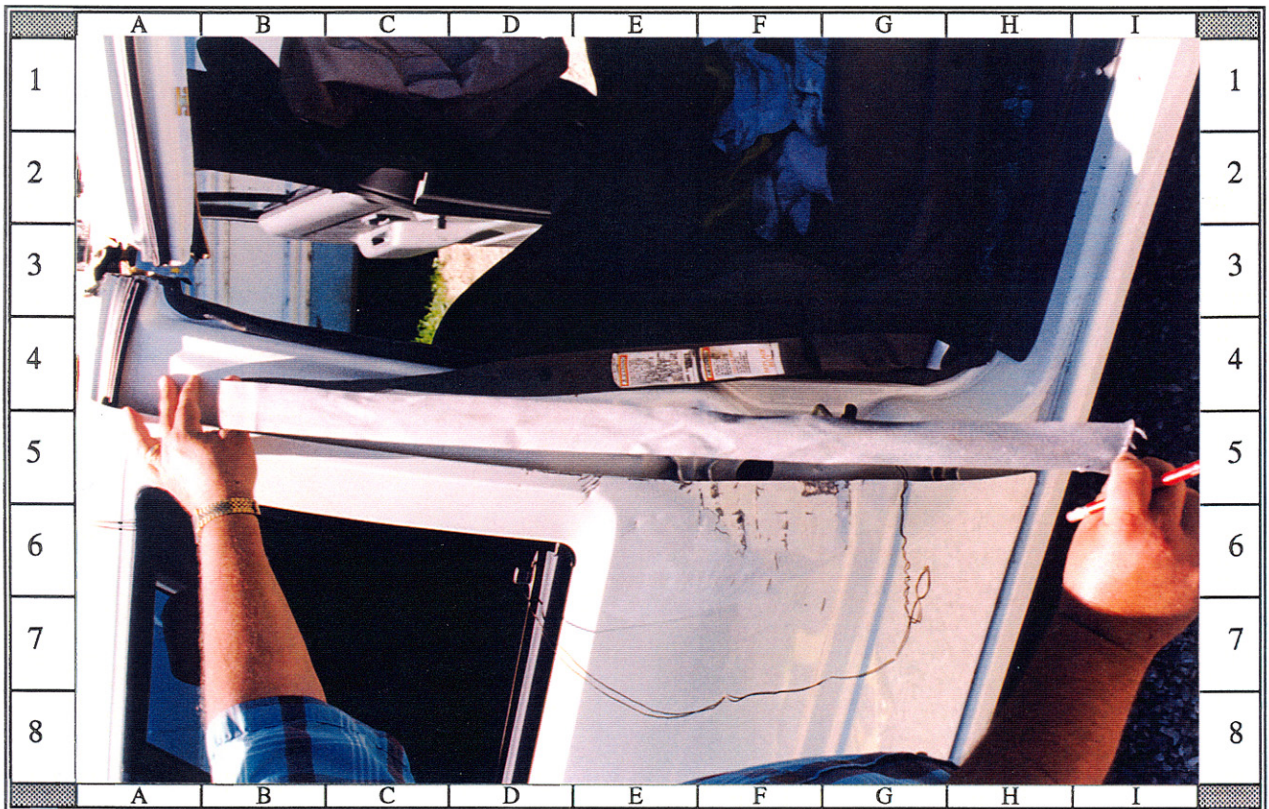
75: Top (cells B4--B5) side of Case Vehicle's right front safety belt showing occupant loading stretch marks; NOTE: extrication cut to right roof side rail

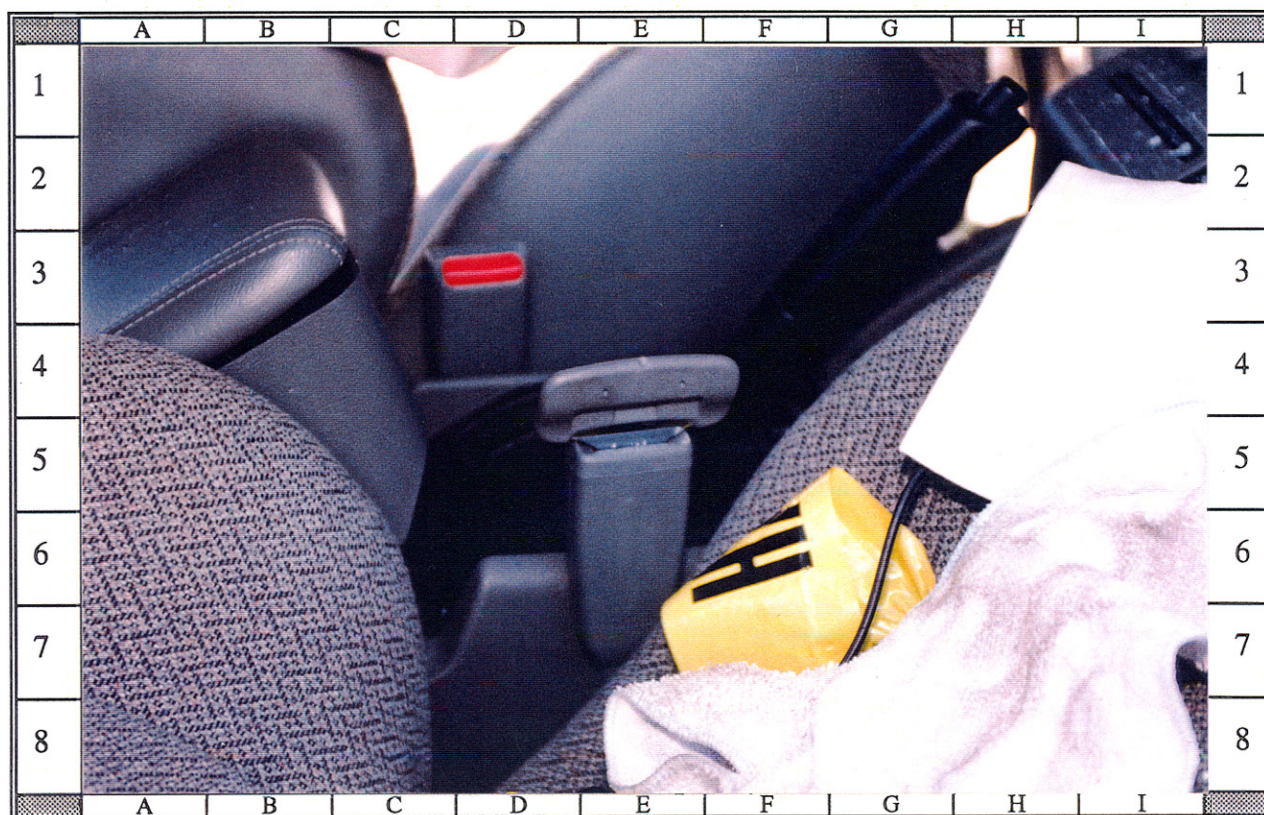
78: Close-up of Case Vehicle's right front safety belt latch assembly (i.e., connection of male and female ends) viewed from right; NOTE: belt cut for extrication

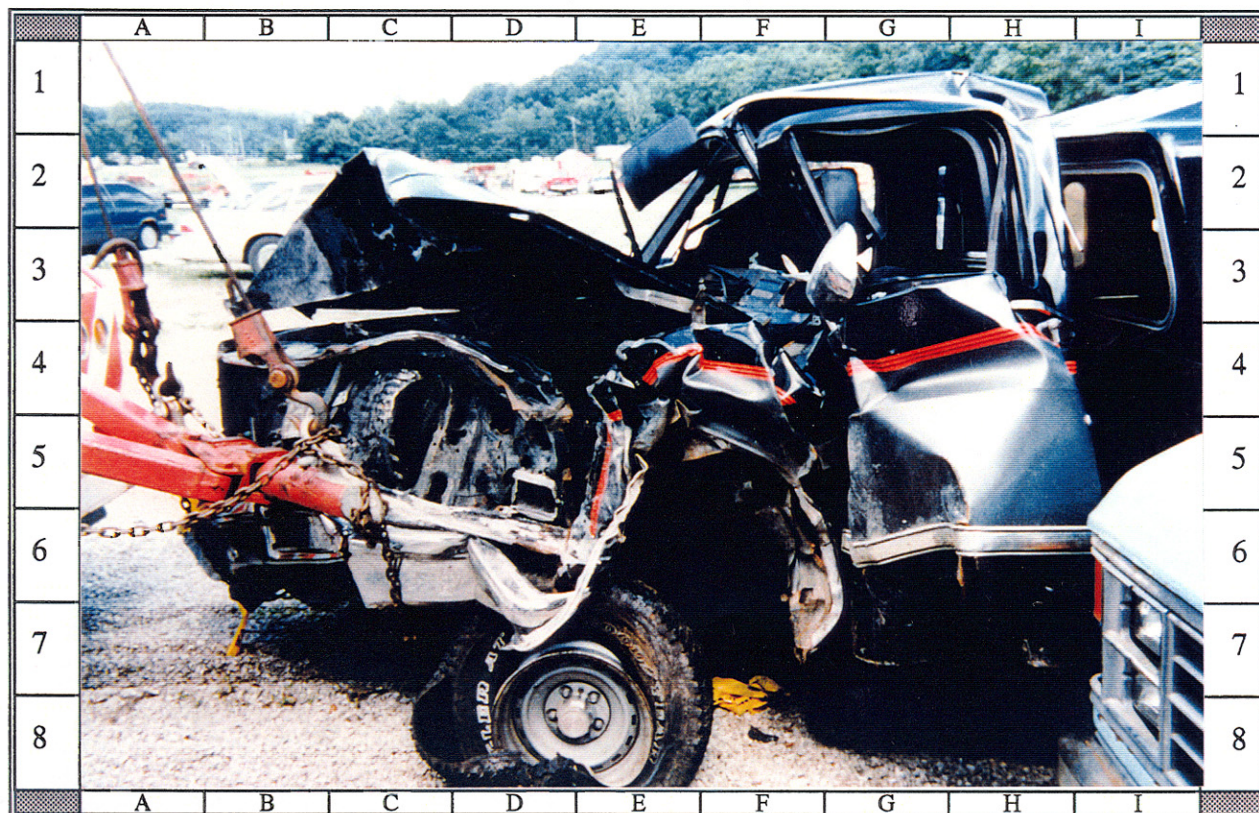
79: Case Vehicle's second seating area viewed through disintegrated left rear glazing showing outboard 3-point safety belts and adjustable head restraints

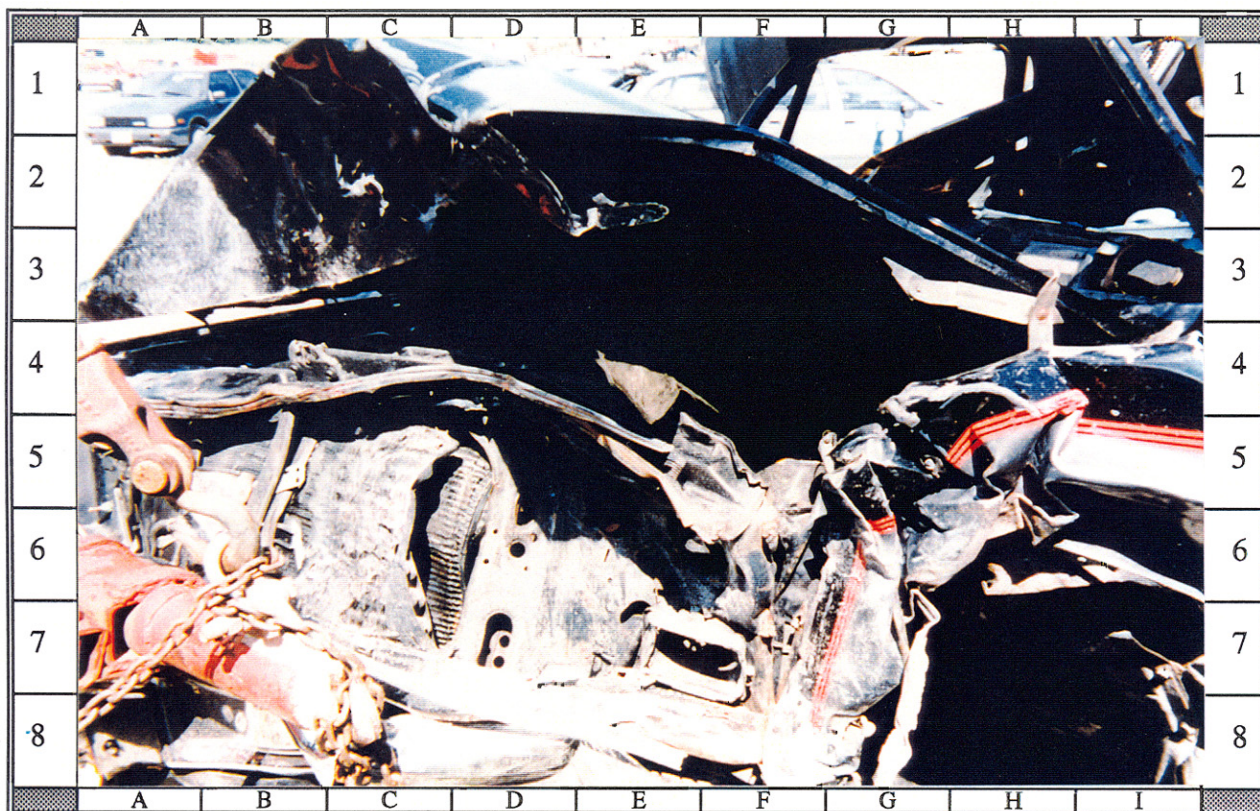
80: 1986 GMC pickup's (Vehicle #2's) damaged front viewed from left; NOTE: extent of crush and indirect damage to left "A"-pillar

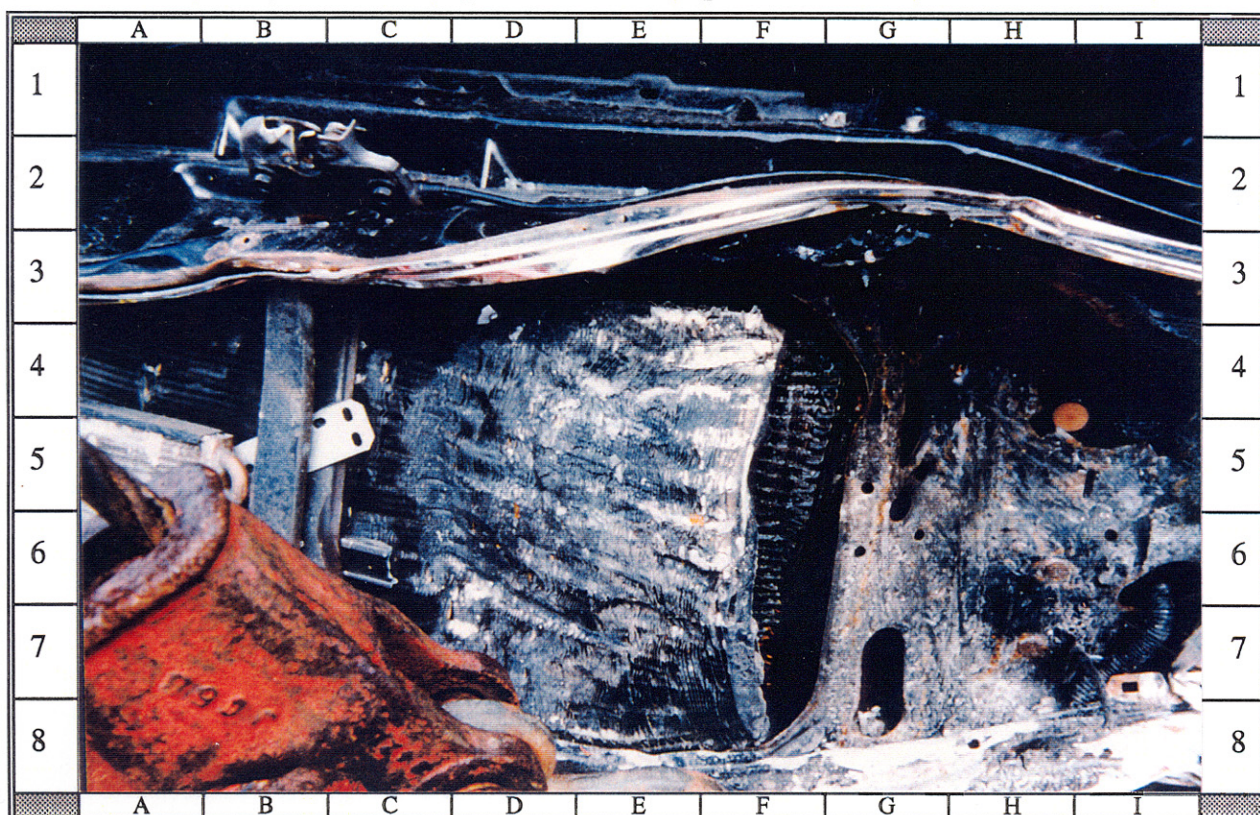
81: Close-up of Vehicle #2's damaged front viewed from approximate 30 degrees left of front; NOTE: orange metal at left of photo is wrecker's tow bar

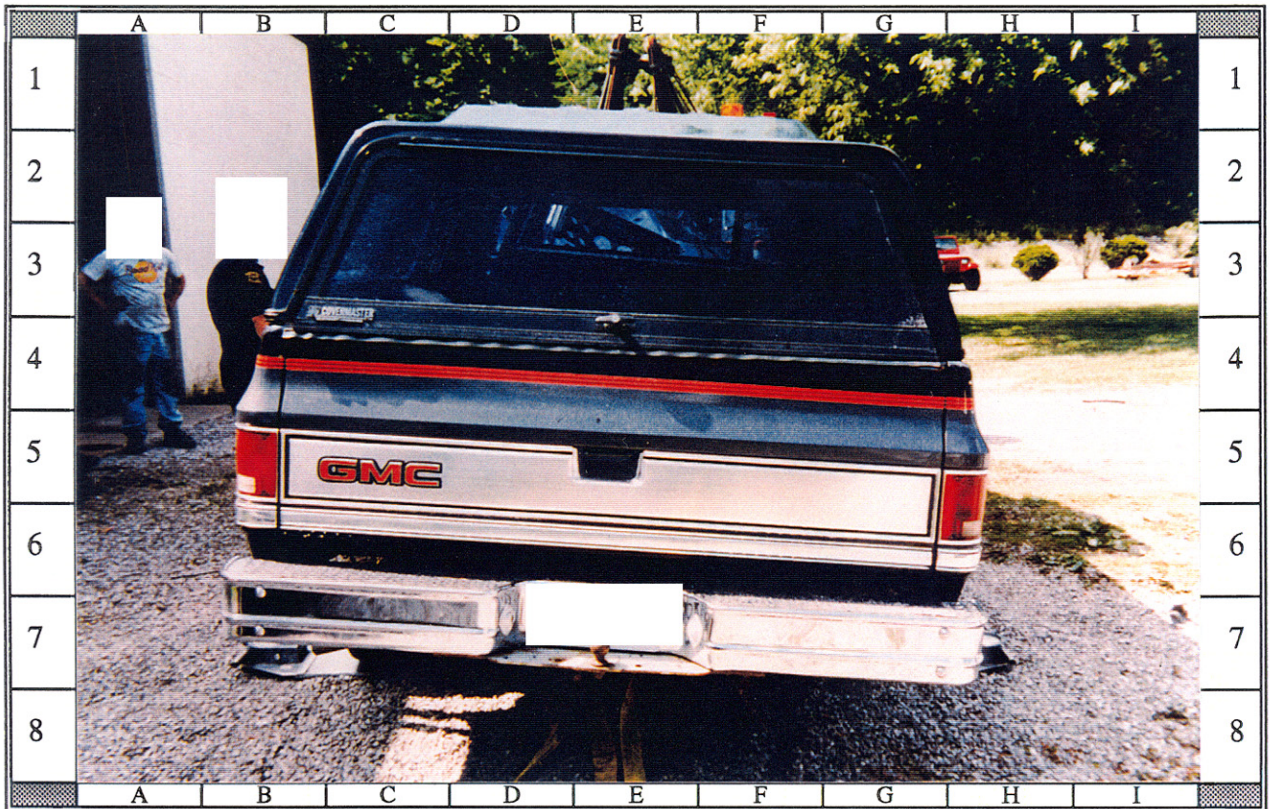
82: Close-up view of Vehicle #2's damage front center viewed from approximate 30 degrees left of front; NOTE: damage to hood latch and radiator

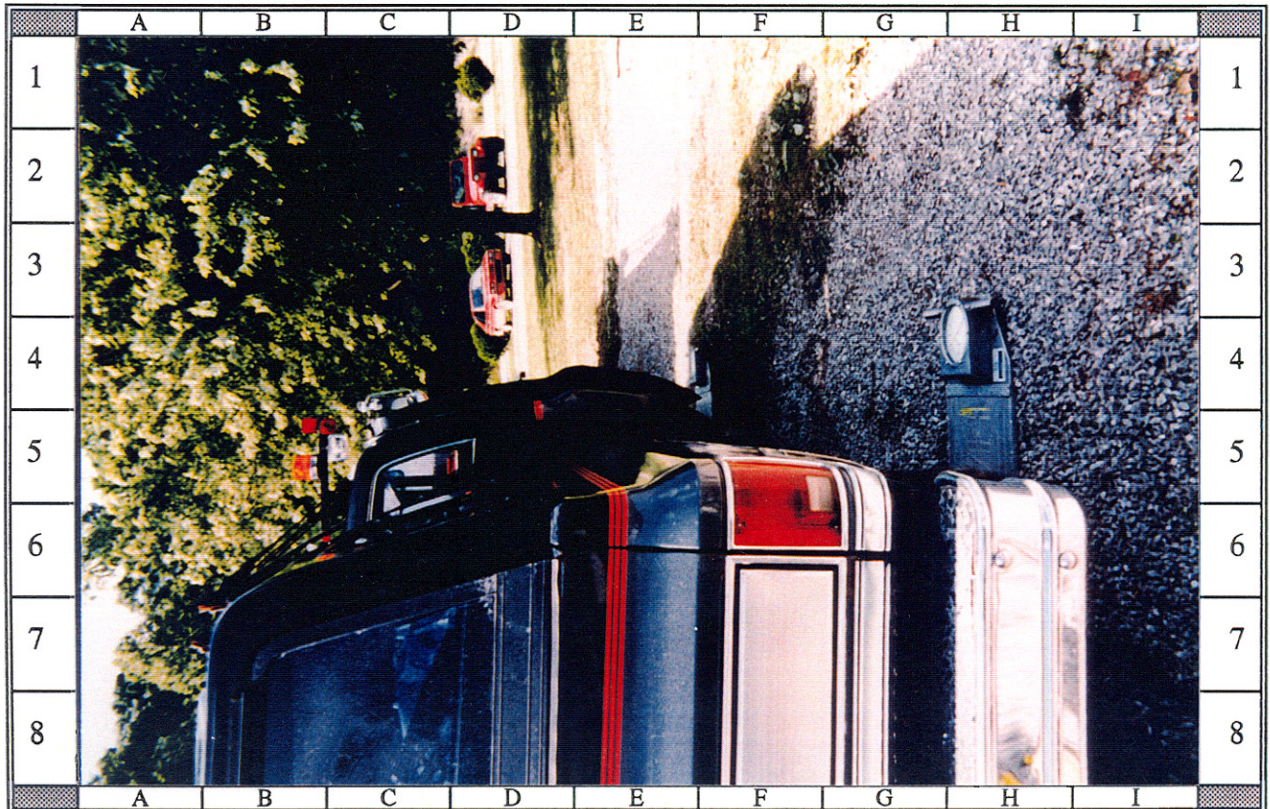
84: Reference line view of Vehicle #2's right side from rear showing extensive shifting of cab

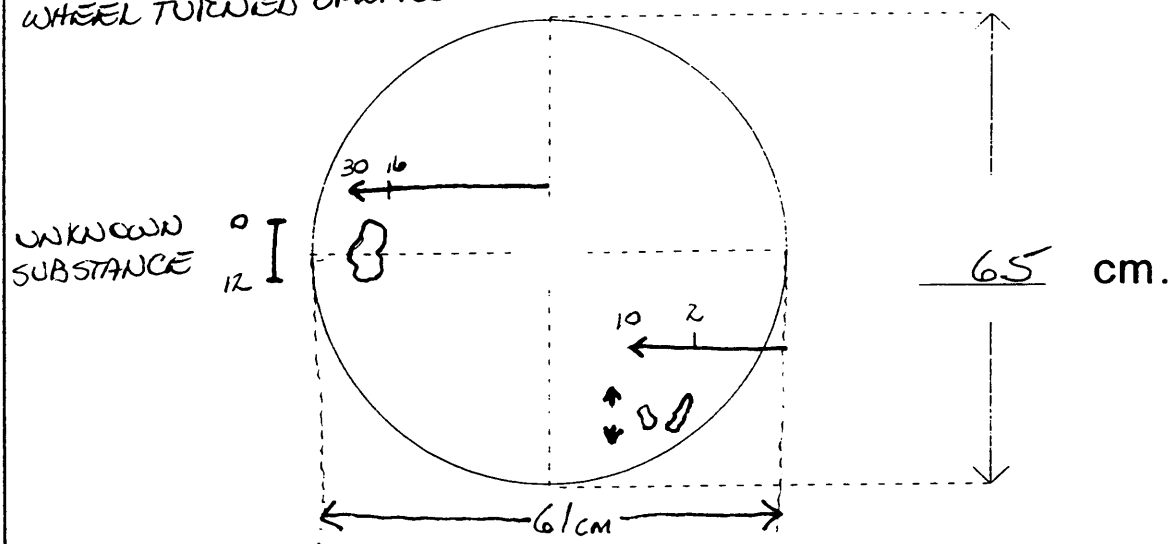
1. SKETCH DAMAGE AND CONTACT EVIDENCE ON DRIVER AIR BAG (Front)

MEASURED AS IF
WHEEL TURNED UPWARDS
